Analysis of the failure of a vacuum spin-pit drive turbine spindle shaft

**ANALYSIS OF THE FAILURE OF A VACUUM SPIN-PIT
DRIVE TURBINE SPINDLE SHAFT**

13. ABSTRACT (maximum 200 words) The Naval Postgraduate School's Rotor Spin Research Facility experienced a failure in the Spring of 2005 in which the rotor dropped from the drive turbine and caused extensive damage. A failure analysis of the drive turbine spindle shaft was conducted in order to determine the cause of failure: whether due to a material or design flaw. Also, a dynamic analysis was conducted in order to determine the natural modes present in the system and the associated frequencies that could have contributed to the failure of the shaft. It was concluded that the failure was due to low cycle fatigue, a possible stress concentration was identified, and a torsional mode was found near the speed at which failure occurred.

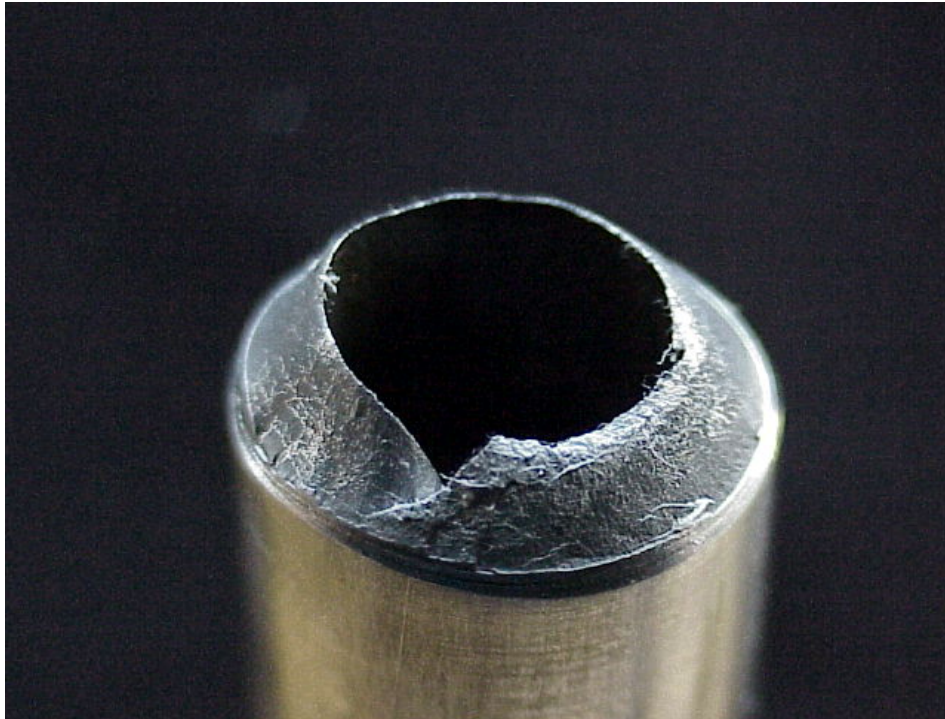
Figure 9. Upper Spindle Fracture Surface

The shaft was removed from the spin pit and care was taken to not damage the fracture surfaces on the spindle. Photographs were taken, as shown in Figures 9-13. A cursory visual analysis of the failed shaft and photographs revealed extensive plastic deformation and a generally dull, fibrous surface texture, - two observations that are strongly indicative of ductile failure by microvoid formation and coalescence. Also, the failure plane was approximately 45 degrees to the longitudinal axis, - suggestive of a ductile fracture in tension. The elongation and deformation was most noticeable on the outer diameter of the shaft whereas the inner diameter remained relatively unchanged.
